1 CASE STUDY OF OCEAN MODULES TUNNEL INSPECTION SYSTEM

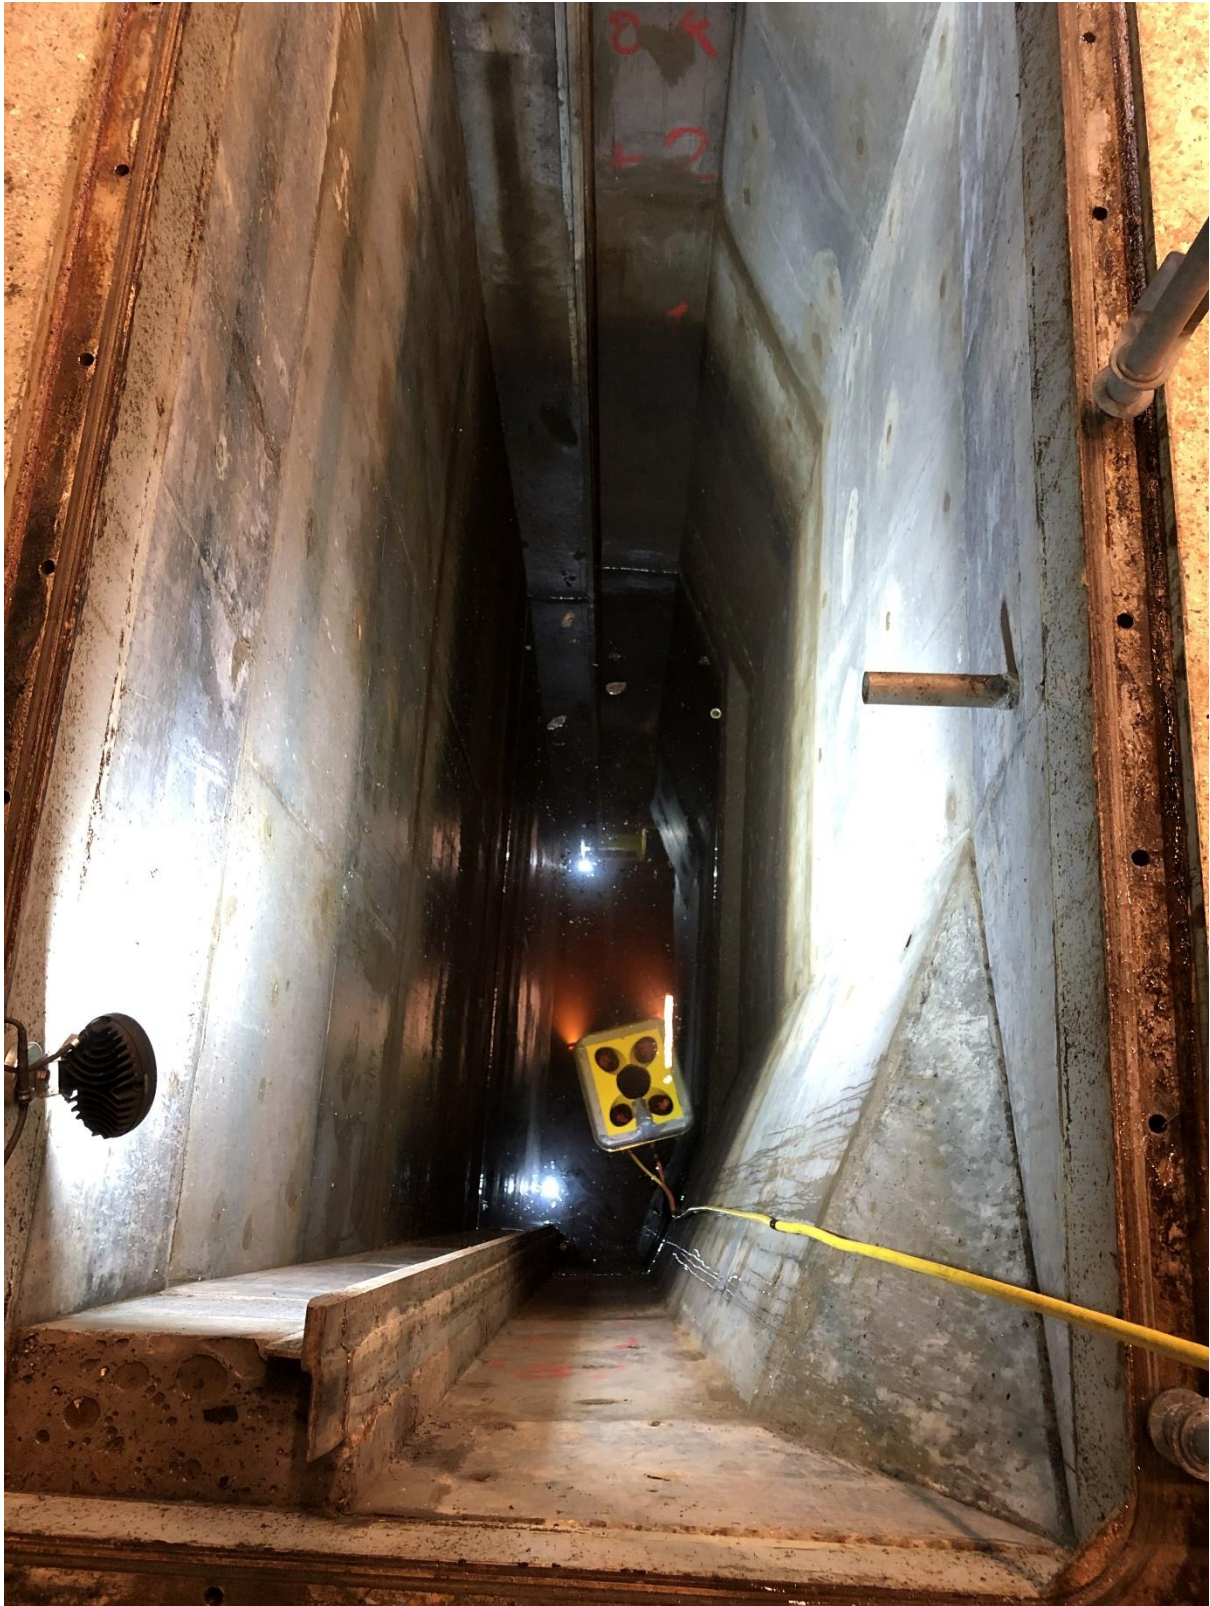
Figure 5. The entrance was narrow, but since the ROV can maneuver with 360 degrees of freedom, it was not difficult to dive down into the tunnel.

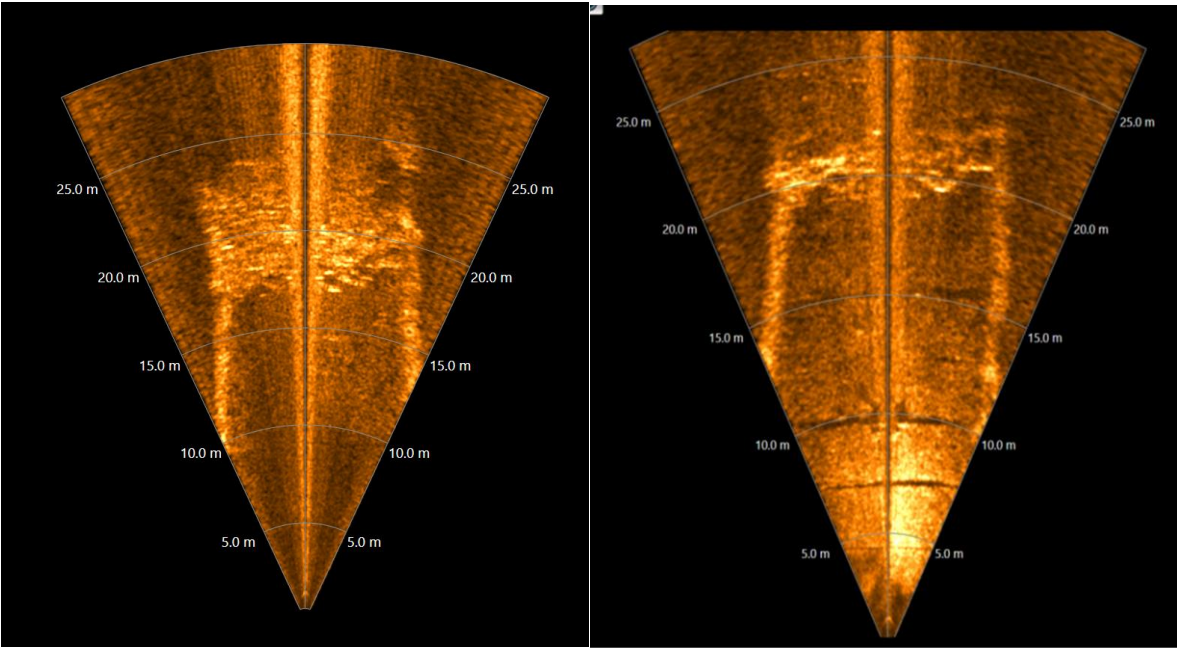
The investigation was started at the exit. The ROV managed to penetrate 1900 meters into the tunnel without any problems. No blockage was found. On the second day the ROV was dropped into the tunnel through a 10 meter shaft so tha the ROV could enter the tunnel after the turbines. After 400 meters the very obvious blockage was found.

Figure 6. The blockage was clearly visible in the BluView sonar image.

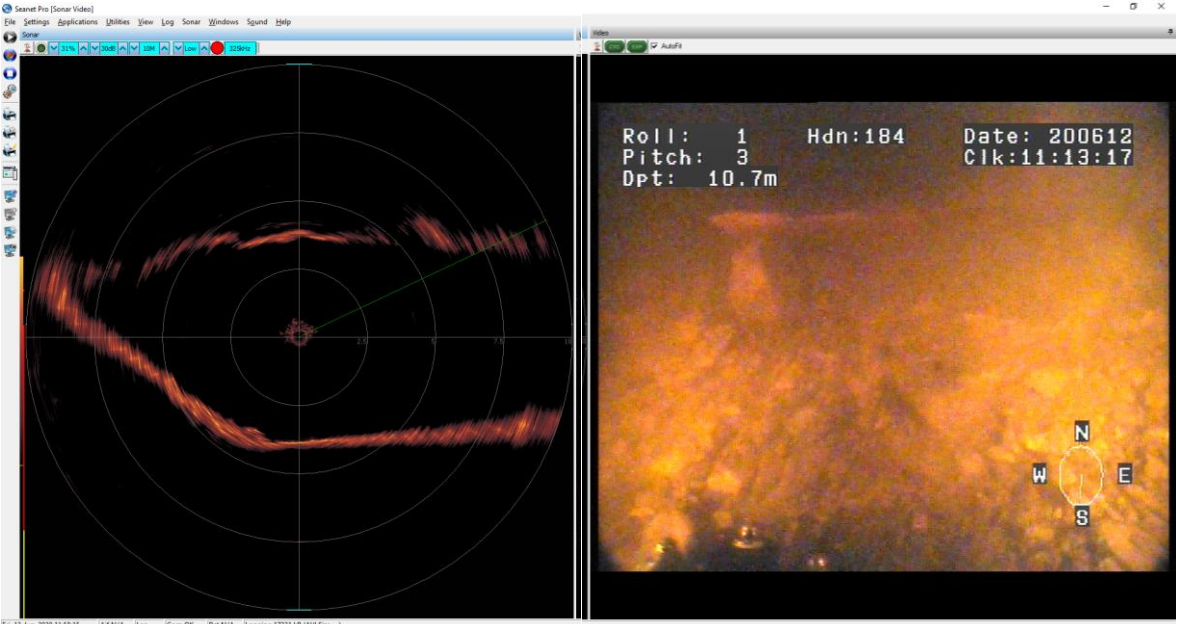
Figure 7. When the ROV was turned 90 degrees (perpendicular to the tunnel) the blockage was also visible in the profiling sonar. It was evident that the roof of the tunnel had collapsed. The visibility was extremely poor but driving close to the blockage we could visually identify the granite rubble.
